Accessibility at Astbury Mere Country Park

Sandy Lane, Congleton, CW12 4FP

Written by Dr Deborah Lawson

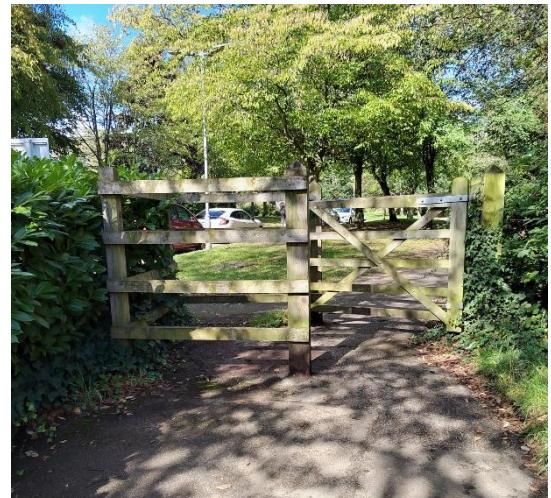
- **Main entrance (Sandy Lane off Newcastle Road):**
 - Pedestrian access is via a kissing gate (manoeuvring space approx. 159 cm x 106 cm).
 - This may be difficult for some wheelchair and mobility-scooter users to use independently, and some larger wheelchairs or mobility scooters may not fit.
 - There are some uneven sections of the path between the kissing gate and the toilets, caused by tree roots pushing up through the hardstanding. These do not run the full width of the path, so they can be avoided.

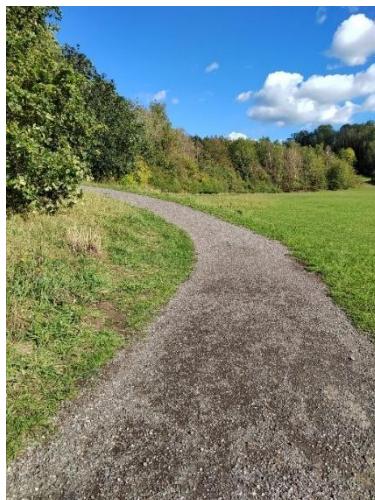
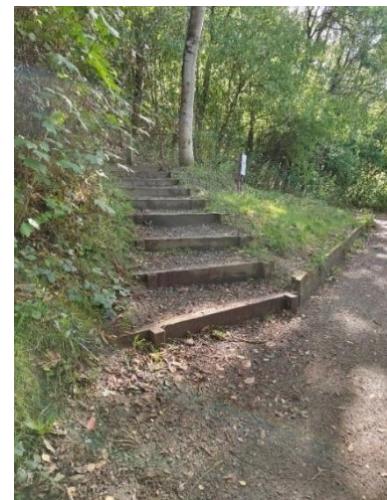
- Alternative step-free access is available from Ennerdale Drive, where there is an open gate. The path gradient here is steep, and there is no parking at this entrance (see left photo).
- There are steps from Wagg's Road/Banky Fields and from Astbury Street (not accessible).
- The Water Sports Centre entrance on Newcastle Road slopes down to the Mere, providing access for Water Sports Centre customers and nearby homes. Parking here is not for general visitors, and there is no wheelchair-accessible path along the access road itself.

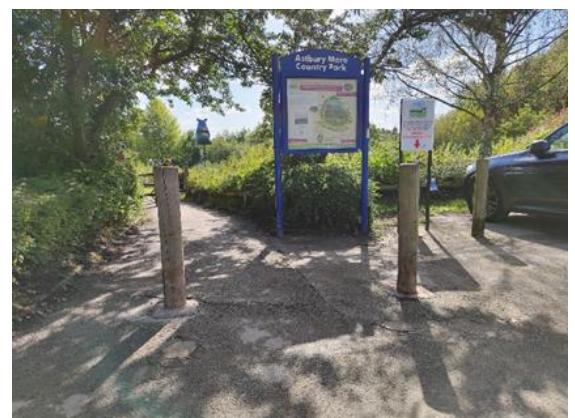
- After passing through bollards, there are two staggered timber barriers to pass through (gaps approx. 112 cm and 100 cm).

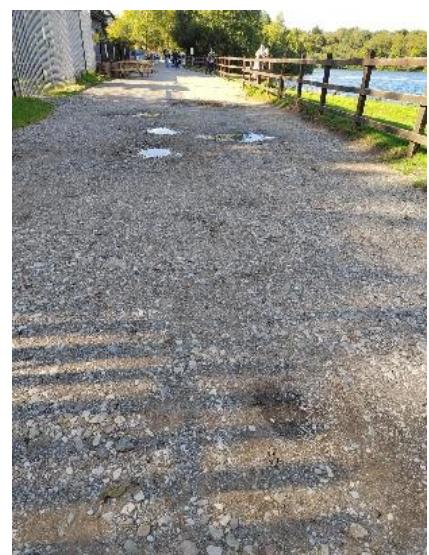
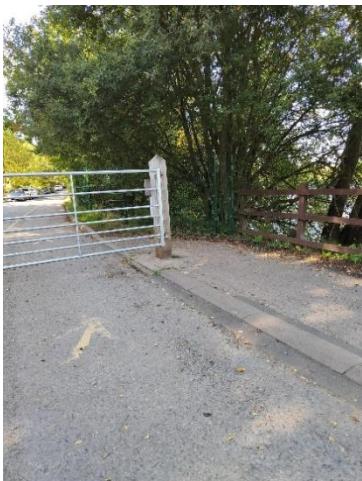
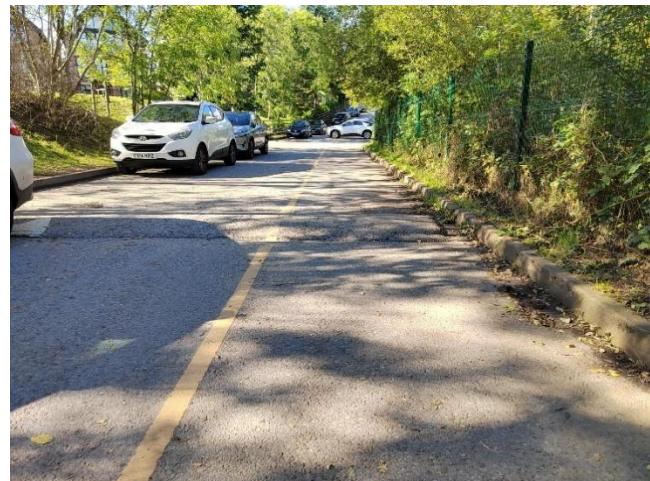
- As you approach the Water Sports Centre, there is some larger gravel on the floor and uneven terrain (though the uneven terrain can mostly be avoided).
- There is a two-metre-wide hardstanding bypass around a closed gate (see the photo on the left on the next page).

- Dropped kerbs here have been improved with tarmac, but there is still a slight ridge going up and down them.
- To continue the route, visitors need to cross a raised speed hump in the road (see right photo below).

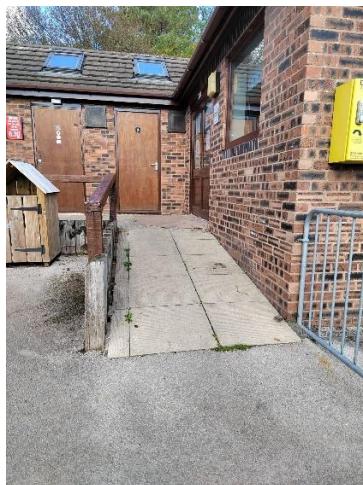
- Doorway approx. 80 cm wide.
- Internal space approx. 155 cm x 190 cm, but the sink, WC and nappy bin reduce the usable space.
- Left-hand transfer when seated on the WC.
- Grab rails by the WC: one drop-down, one wall-mounted.
- Ramp access (with a single handrail) to the accessible toilet (the gradient may feel a little steep for some users).
- Points to note: the sink is slightly high if using a wheelchair; the turning space may be tight for larger wheelchairs.

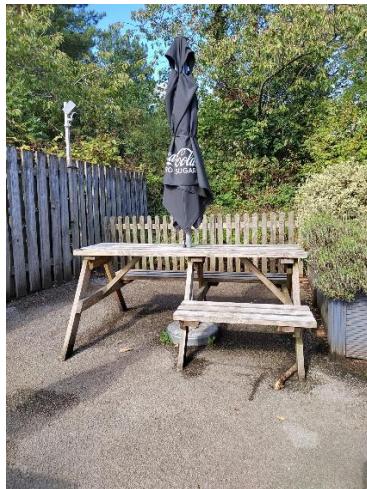
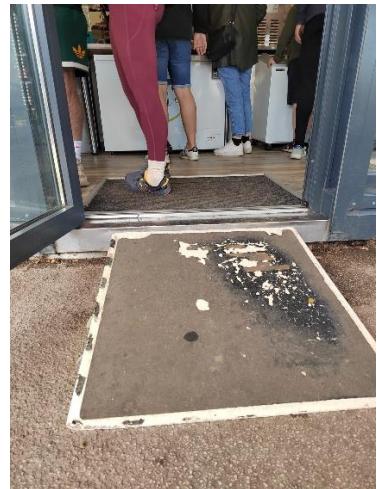
- The café has a ramped entrance and two small thresholds that may be difficult for some wheelchair users.
- Two wheelchair-accessible outdoor tables are provided for customers.
