# Accessibility at Astbury Mere Country Park

Sandy Lane, Congleton, CW12 4FP

We want all visitors to enjoy Astbury Mere. The following information is designed to help you plan your visit. Please note that Astbury Mere is a country park, so while many accessible features are provided, paths and surfaces are part of a natural setting and may be uneven or bumpy in places.

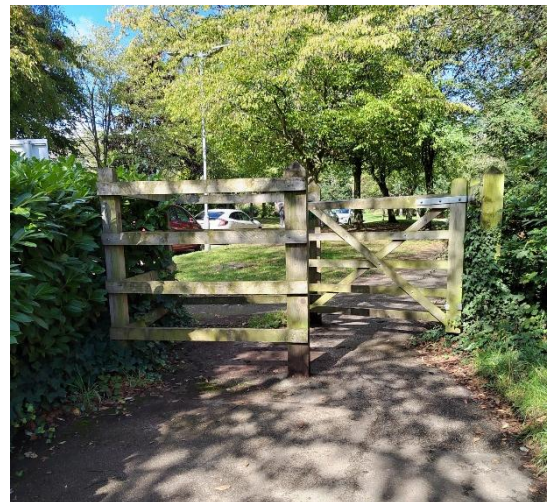
- **Main entrance (Sandy Lane off Newcastle Road):**
  - Pedestrian access is via a kissing gate (manoeuvring space approx. 159 cm x 106 cm).
  - This may be difficult for some wheelchair and mobility-scooter users to use independently, and some larger wheelchairs or mobility scooters may not fit.
  - There are some uneven sections of the path between the kissing gate and the toilets, caused by tree roots pushing up through the hardstanding. These do not run the full width of the path, so they can be avoided.

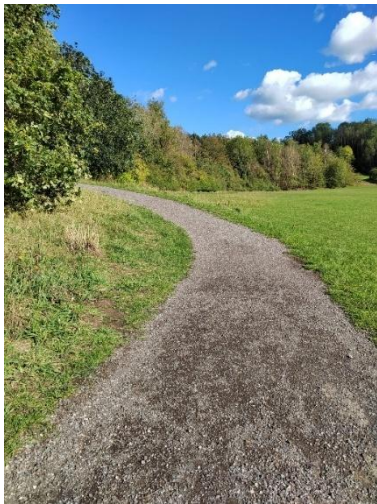
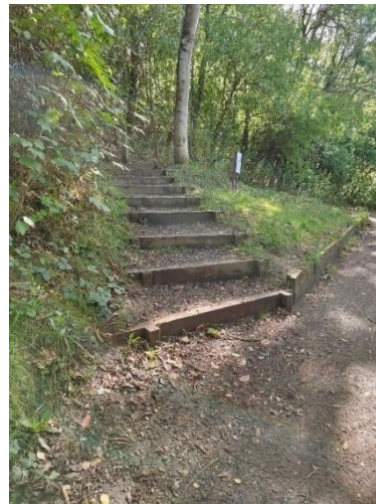
- Alternative step-free access is available from Ennerdale Drive, where there is an open gate. The path gradient here is steep, and there is no parking at this entrance (see left photo).
- There are steps from Wagg's Road/Banky Fields and from Astbury Street (not accessible).
- The Water Sports Centre entrance on Newcastle Road slopes down to the Mere, providing access for Water Sports Centre customers and nearby homes. Parking here is not for general visitors, and there is no wheelchair-accessible path along the access road itself.

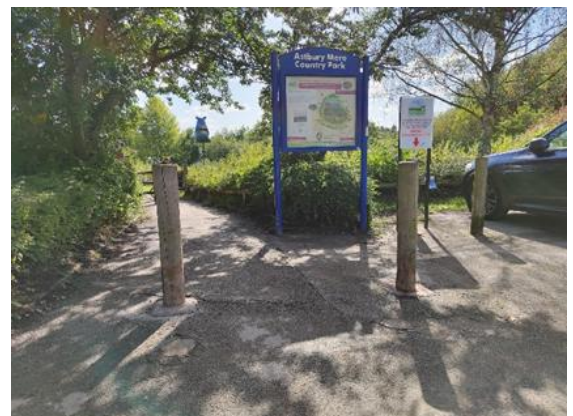
- After passing through bollards, there are two staggered timber barriers to pass through (gaps approx. 112 cm and 100 cm).

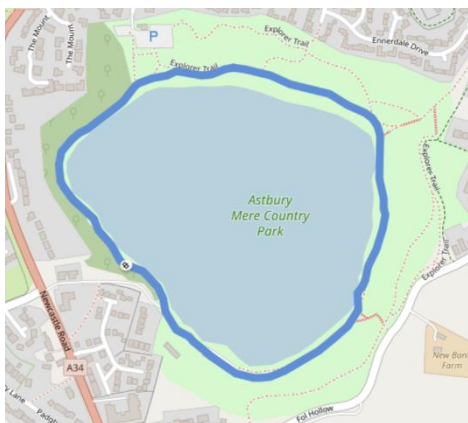
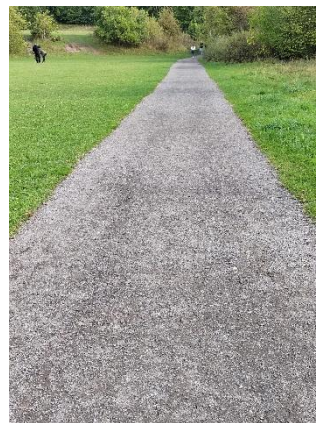
- The circular route around the Mere is approx. **1 mile (1.6 km)**.

- Surfaces are firm (hardstanding and fine gravel).
- In windy weather, some dust may blow across the path.
- Paths are wide enough for a wheelchair and a companion or assistance dog, and for others to pass.

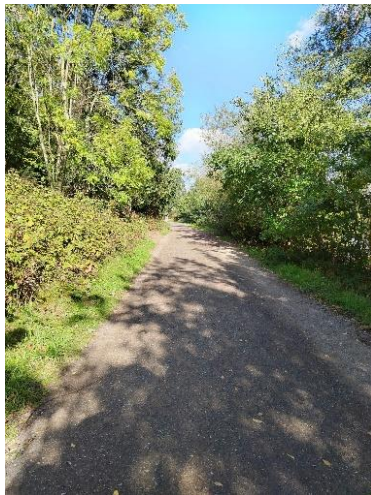
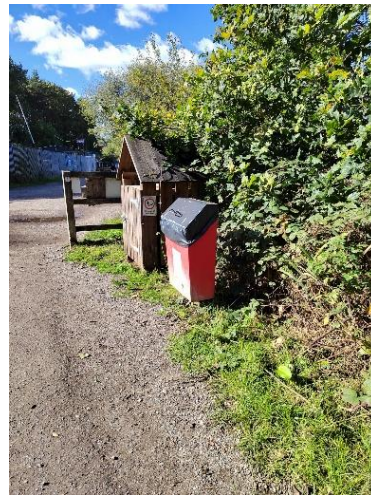
- There is a forest area off the main circuit. However, this is not wheelchair accessible due to rough, uneven terrain and tree stumps.
- After the Water Sports Centre (if passing the building on your left), the outer edge of the main path slopes slightly towards the Mere. This can be avoided by keeping towards the left of the path.
- General waste bins and dog waste bins are positioned along the route, at an accessible height. Dog waste bins have heavy lids with pull handles.

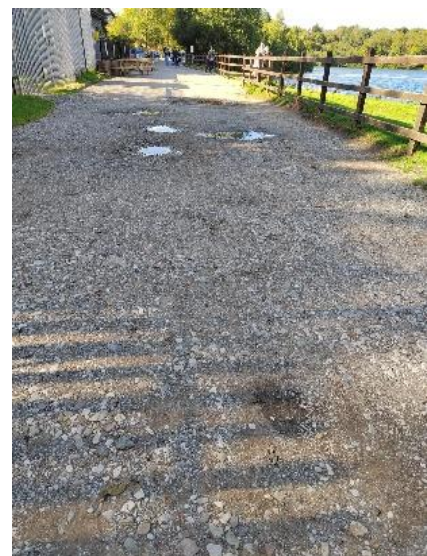
- As you approach the Water Sports Centre, there is some larger gravel on the floor and uneven terrain (though the uneven terrain can mostly be avoided).
- There is a two-metre-wide hardstanding bypass around a closed gate (see the photo on the left on the next page).

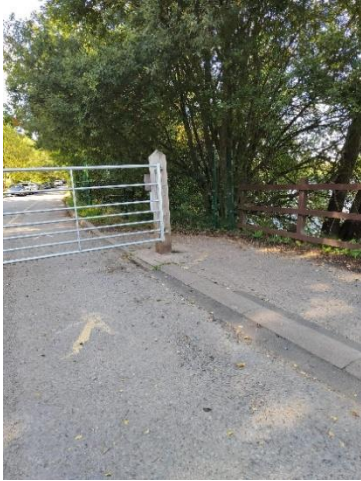
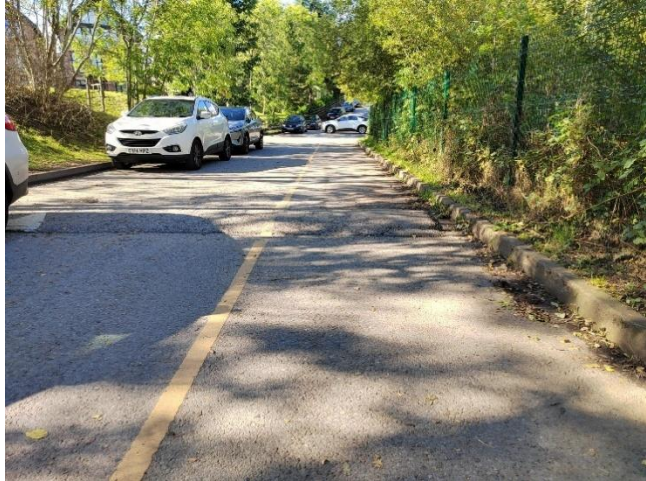
- Dropped kerbs here have been improved with tarmac, but there is still a slight ridge going up and down them.
- To continue the route, visitors need to cross a raised speed hump in the road (see right photo below).

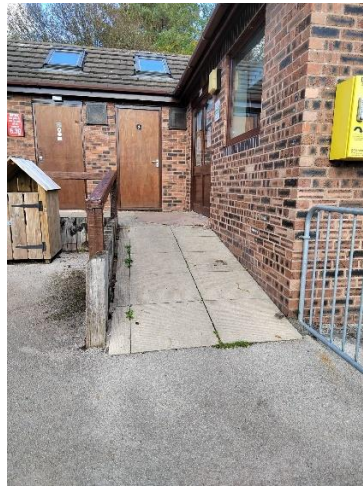
- Doorway approx. 80 cm wide.
- Internal space approx. 155 cm x 190 cm, but the sink, WC and nappy bin reduce the usable space.
- Left-hand transfer when seated on the WC.
- Grab rails by the WC: one drop-down, one wall-mounted.
- Ramp access (with a single handrail) to the accessible toilet (the gradient may feel a little steep for some users).
- Points to note: the sink is slightly high if using a wheelchair; the turning space may be tight for larger wheelchairs.

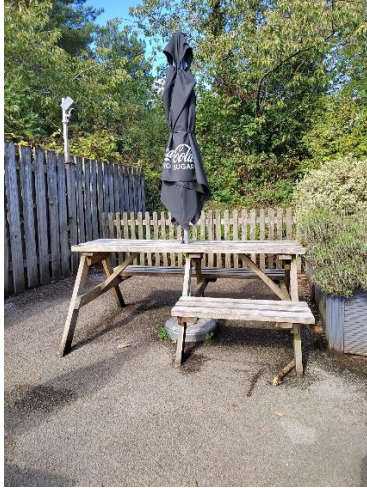
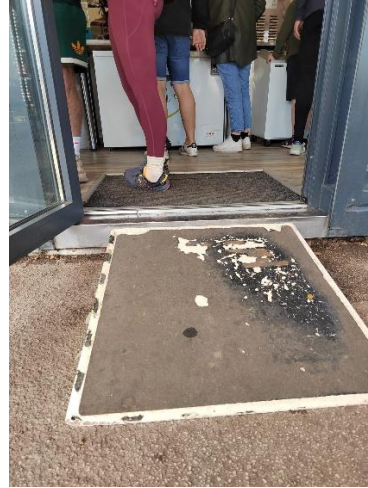
- The café has a ramped entrance and two small thresholds that may be difficult for some wheelchair users.
- Two wheelchair-accessible outdoor tables are provided for customers.
